**Flood Control Project Maintenance
Levee Inspections**
LMA District Cover Sheet
Spring 2018 Levee Inspection Results

Reclamation District No. 2103 Wheatland Vicinity

Spring 2018 Levee Inspection Results

Waterway			Bank	Unit Miles
Unit No. 01 South Dry Creek			Left	4.64
	Spring (March - May)	Summer (June - August)	(September - November) Fall	Winter (December - February)
Unit Maintenance Rating (Fall Only)				
Date of Inspection	4/18/2018 - 4/18/2018			
DWR Inspector	Sterling York			
Accompanied By	Tom Engler RD 2103			
	Joe Conant RD 817

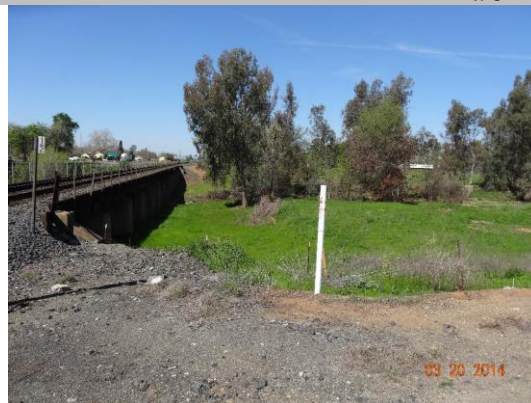
Photo 3 of 3 : UCIP_SP_2018_39987_71886.jpg

LM Start	0.56	Rating **	M	Issue No.	32 (cont)
LM End	0.56	Issue Type +	En	Location *	
Category	Supplemental			GPS Latitude/Longitude	
				Start	End
Item	DWR UCIP Field Study			39.022665 °	39.022665 °
				-121.444688 °	-121.444688 °
DWR ID					
Comment Code					
Inspector Comment					
FS_ID:39987 DS_ID:24879 EP_NO: N/A Repair Type: Non-Urgent Crossing Status: Indicator Found UCIP Comments: Need to contact owner to obtain depth of line through levee. Also need permit authorizing conduit through levee. FIELD_STRUCT_DESC: Conduit line through levee. Markers visible on both sides. FS Date: 3/4/2014

View of waterward side.

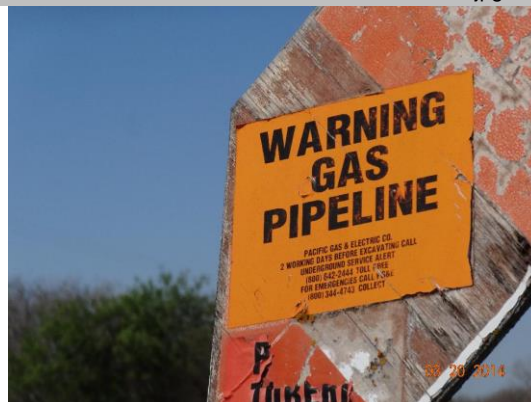
Photo 3 of 3 : UCIP_SP_2018_38323_69858.jpg

Comment Code						
Inspector Comment						
FS_ID:38323 DS_ID:19469 EP_NO: 2098 Repair Type: Non-Urgent Crossing Status: Indicator Found UCIP Comments: Need to contact owner to determine status of crossing. Need date of last inspection and confirmation that crossing is still in operable condition. FIELD_STRUCT_DESC: 16-inch steel gas line through the levee, 3 feet below the crown. Marker on waterside (WS) slope. (16-inch line authorized under Permit No. 2098, 1955-Pacific Gas and Electric Company [PG&E]). [Additional Reference(s): DWR Levee Logs, 2005. USACE Sacramento O&M Manual Unit No. 146, November 1962, (HLM 0.56)] FS Date: 3/20/2014

Contact information of owner.

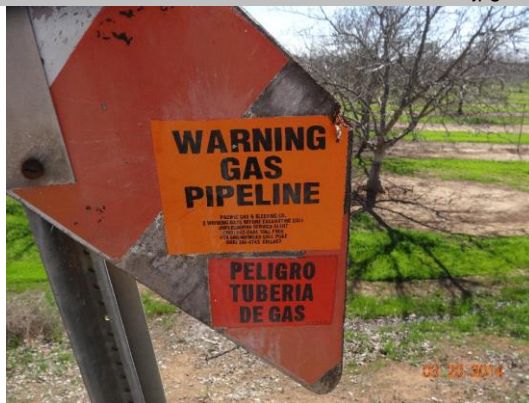
Photo 2 of 3 : UCIP_SP_2018_38324_69863.jpg

FS_ID:38324
DS_ID:19470
EP_NO: 789
Repair Type: Non-Urgent
Crossing Status: Indicator Found
UCIP Comments: Need to contact owner to determine status of crossing. Need date of last inspection and confirmation that crossing is still in operable condition.
FIELD_STRUCT_DESC: 16-inch steel gas line through levee, 3 feet below the crown. Concrete inspection chamber (24-inch by 18-inch box with 4-inch walls) on the waterside (WS) shoulder, covered with dirt. Gas line marker on landside (LS) slope. Extends underneath Dry Creek channel, covered with concrete slab approximately 18-inches wide. (8.625-inch gas line authorized under Permit No. 789, 1939-Pacific Gas and Electric Company [PG&E]). [Additional Reference(s): DWR Levee Logs, 2005, 16-inch gas line. USACE Sacramento O&M Manual Unit No. 146, November 1962, (HLM 0.63), 16-inch gas line]
FS Date: 3/20/2014

Contact information for gas pipeline.

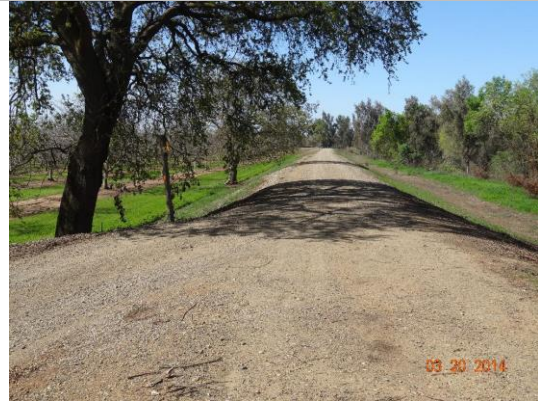
Photo 3 of 3 : UCIP_SP_2018_39988_71888.jpg

LM Start	0.81	Rating **	M	Issue No.	35 (cont)	
LM End	0.81	Issue Type +	En	Location *		
Category	Supplemental			GPS Latitude/Longitude		
				Start	End	
Item	DWR UCIP Field Study			39.024725 °	39.024725 °	
				-121.440978 °	-121.440978 °	
DWR ID						
Comment Code						
Inspector Comment						
FS_ID:39988 DS_ID:24880 EP_NO: N/A Repair Type: Non-Urgent Crossing Status: Indicator Found UCIP Comments: No marker found on waterward side--need to confirm with owner if crossing goes through levee. If so, need depth of crossing through levee. Also need to obtain permit number used to authorize crossing. FIELD_STRUCT_DESC: Conduit line through levee of unknown material or depth below the crown. Marker visible on landside (LS). FS Date: 3/4/2014

View of levee at crossing.

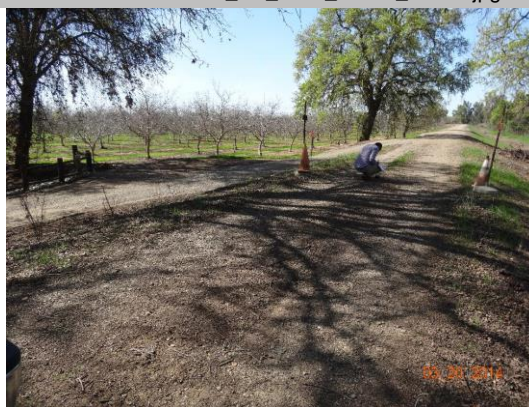
Photo 3 of 3 : UCIP_SP_2018_38325_69873.jpg

LM Start	0.82	Rating **	A/W	Issue No.	36 (cont)	
LM End	0.82	Issue Type +	Ma	Location *		
Category	Supplemental			GPS Latitude/Longitude		
				Start		End
Item	DWR UCIP LMA Responsibility			39.024811 °		39.024811 °
				-121.440750 °		-121.440750 °
DWR ID						
Comment Code						
Inspector Comment						
FS_ID:38325 DS_ID:19471 EP_NO: N/A Repair Type: No Action Needed Crossing Status: Found UCIP Comments: FIELD_STRUCT_DESC: 36-inch corrugated metal drainage pipe through the levee, 14.4 feet below the crown. Concrete headwall, flap-gate, and 3-foot by 6-foot concrete splash apron located on the waterside (WS) toe. Outfall drain from old Grasshopper Slough. [Additional Reference(s): DWR Levee Logs, 2005. USACE Sacramento O&M Manual Unit No. 146, November 1962, (HLM 0.83)] FS Date: 3/20/2014

View of levee crown at crossing.

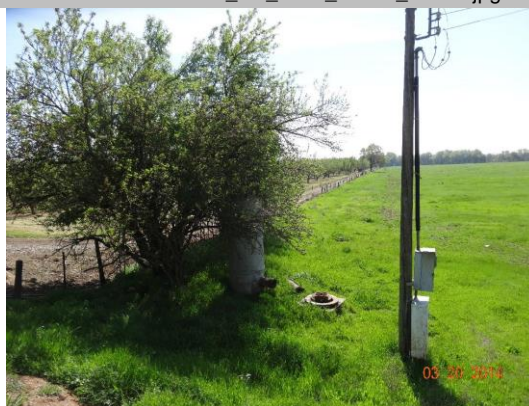
Photo 1 of 3 : UCIP_SP_2018_38327_69881.jpg

LM Start	1.86	Rating **	M	Issue No.	38
LM End	1.86	Issue Type +	En	Location *	
Category	Supplemental			GPS Latitude/Longitude	
				Start	End
Item	DWR UCIP Field Study			39.029694 °	39.029694 °
				-121.423946 °	-121.423946 °
DWR ID					
Comment Code					
Inspector Comment					
FS_ID:38327 DS_ID:19512 EP_NO: N/A Repair Type: Non-Urgent Crossing Status: Indicator Found UCIP Comments: Unable to determine if there is a crossing through pipe. Will need to coordinate with owner to determine additional information about appurtenances found on landward side. FIELD_STRUCT_DESC: Irrigation pump, service pole, and 36-inch concrete standpipe, 5 feet from the landside (LS) toe. No pump was found during field visit 3/20/14. [Additional Reference(s): DWR Levee Logs, 2005] FS Date: 3/20/2014

View of landward side.

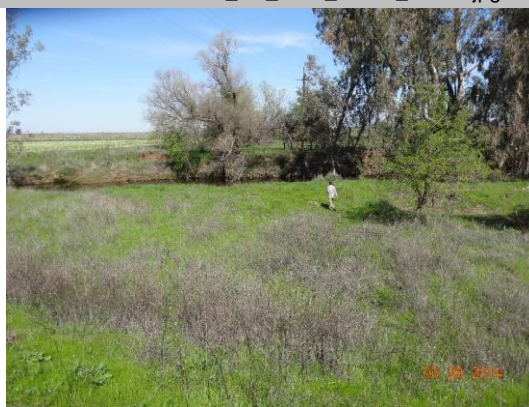
Photo 2 of 3 : UCIP_SP_2018_38327_69880.jpg

View of waterward side.

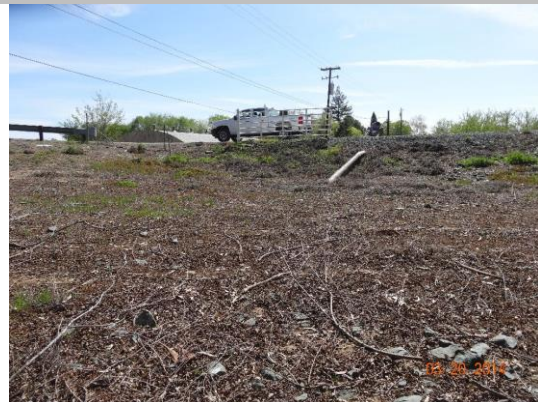
Photo 1 of 3 : UCIP_SP_2018_38331_69894.jpg

LM Start	2.64	Rating **	M	Issue No.	39
LM End	2.64	Issue Type +	En	Location *	
Category	Supplemental			GPS Latitude/Longitude	
				Start	End
Item	DWR UCIP Field Study			39.031590 °	39.031590 °
				-121.409870 °	-121.409870 °
DWR ID					
Comment Code					
Inspector Comment					
FS_ID:38331					
DS_ID:19477					
EP_NO: N/A					
Repair Type: Non-Urgent					
Crossing Status: Found					
UCIP Comments: Need to contact owner to determine status.					
FIELD_STRUCT_DESC: 8-inch steel irrigation pipe through the levee, 3.1 feet below the crown. Siphon breaker on the waterward slope. Pump on the landward side. Pipe crosses creek to orchard on north side. (two 12-inch pipes authorized under Permit No. 1887, 1954-H. B. Waltz, HLM 2.41 and 2.68) [Additional Reference(s): DWR Levee Logs, 2005. USACE Sacramento O&M Manual Unit No. 146, November 1962, (HLM 2.68), 8-inch]					
FS Date: 3/20/2014

View of waterward side.

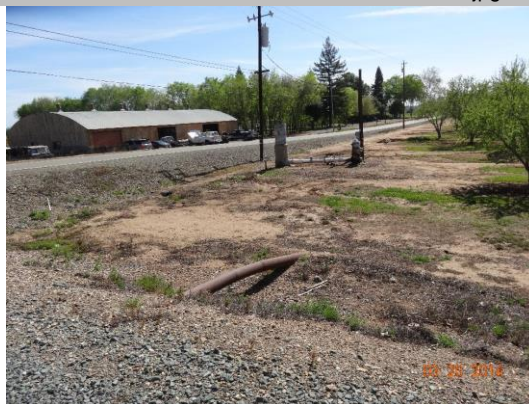
Photo 3 of 3 : UCIP_SP_2018_38331_69892.jpg

LM Start	2.64	Rating **	M	Issue No.	39 (cont)	
LM End	2.64	Issue Type +	En	Location *		
Category	Supplemental			GPS Latitude/Longitude		
				Start		End
Item	DWR UCIP Field Study			39.031590 °		39.031590 °
				-121.409870 °		-121.409870 °
DWR ID						
Comment Code						
Inspector Comment						
FS_ID:38331 DS_ID:19477 EP_NO: N/A Repair Type: Non-Urgent Crossing Status: Found UCIP Comments: Need to contact owner to determine status. FIELD_STRUCT_DESC: 8-inch steel irrigation pipe through the levee, 3.1 feet below the crown. Siphon breaker on the waterward slope. Pump on the landward side. Pipe crosses creek to orchard on north side. (two 12-inch pipes authorized under Permit No. 1887, 1954-H. B. Waltz, HLM 2.41 and 2.68) [Additional Reference(s): DWR Levee Logs, 2005. USACE Sacramento O&M Manual Unit No. 146, November 1962, (HLM 2.68), 8-inch] FS Date: 3/20/2014

View of landward side.

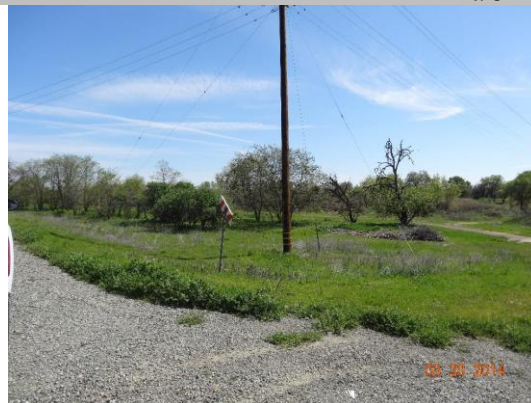
Photo 1 of 2 : UCIP_SP_2018_39992_69914.jpg

LM Start	1.26	Rating **	M	Issue No.	25
LM End	1.26	Issue Type +	En	Location *	
Category	Supplemental			GPS Latitude/Longitude	
				Start	End
Item	DWR UCIP Field Study			38.998301 °	38.998301 °
				-121.415296 °	-121.415296 °
DWR ID					
Comment Code					
Inspector Comment					
FS_ID:39992 DS_ID:19484 EP_NO: 1613 Repair Type: Non-Urgent Crossing Status: Indicator Found UCIP Comments: Need to contact owner to determine status of crossing. Need date of last inspection and confirmation that crossing is still in operable condition. FIELD_STRUCT_DESC: 16-inch steel gas line through the levee, 3 feet below the crown. (16-inch line authorized under Permit No. 1613, 1951-Pacific Gas and Electric Company [PG&E]). [Additional Reference(s): DWR Levee Logs, 2005. USACE Sacramento O&M Manual Unit No. 146, November 1962, (HLM 1.30)] FS Date: 3/20/2014

Marker visible on waterward side.

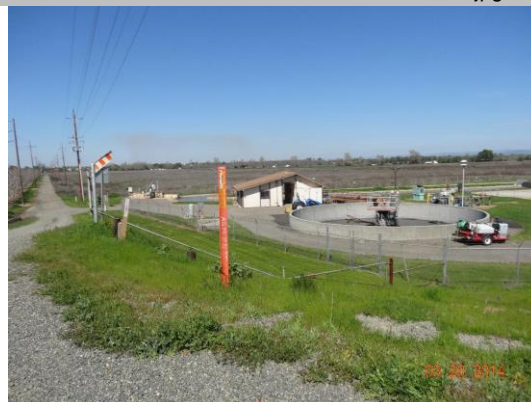
Photo 2 of 2 : UCIP_SP_2018_39992_69913.jpg

Marker visible on landward side.

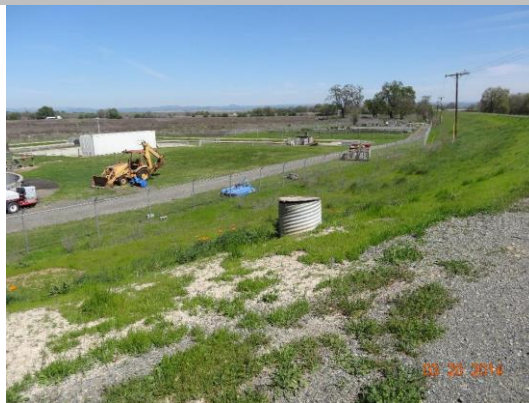
Photo 2 of 2 : UCIP_SP_2018_39993_69911.jpg

FS_ID:39993
DS_ID:19486
EP_NO: 5714
Repair Type: Non-Urgent
Crossing Status: Indicator Found
UCIP Comments: Need to contact owner to confirm crossing and determine status.
FIELD_STRUCT_DESC: 12-inch steel sewer pipes through the levee, 3.1 feet below the crown. Siphon breaker in 24-inch corrugated metal (CM) pipe riser on the landside (LS) shoulder. Standard CM cutoff wall around pipe at centerline of levee. Extends from wastewater treatment plant on landside (LS) to waste water lagoon on waterside (WS). Permit includes construction of lagoon with surrounding short levee, extending from/to project levee. (12-inch pipe authorized under Permit No. 5714, 1968-City of Wheatland). [Additional Reference(s): DWR Levee Logs, 2005]
FS Date: 3/20/2014

CMP riser located on landward side.

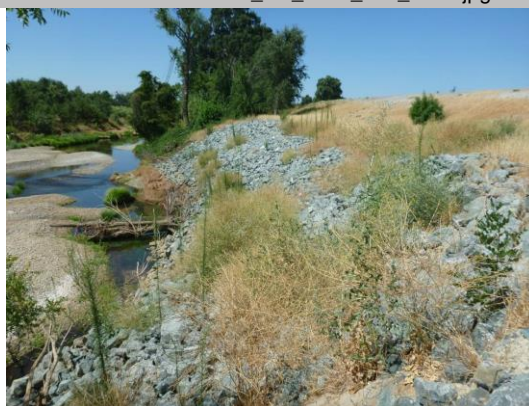
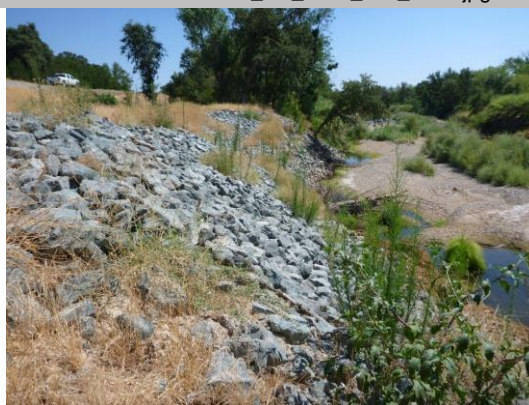
Comment Code						
Inspector Comment						
Levee Evaluation Comments						
Description:2017 Flood Fight Emergency Repair - 200 feet of site repaired in March 2017. Additional 50 feet requires repair after water receded. \$220,000 estimated total for completion and post project permits and mitigation						
Site ID No:488						
Site Designation:LMA-326						
Repair Type: Erosion						
Rating:Area of Concern						
Field Date:7/27/2017						
Notes: Site will likely degrade quickly due to lack of RSP along the lower portion of the bank slope and downstream end of site. At time of field visit, site does not appear to be any imminent threat of failure.

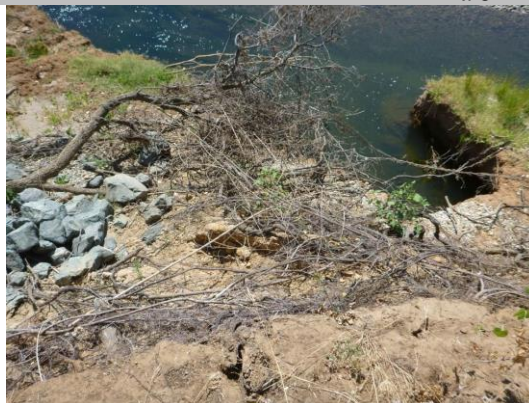
Photo 5 of 5 : LEVAL_SP_2018_488_1812.jpg

Comment Code						
Inspector Comment						
Levee Evaluation Comments						
Description:2017 Flood Fight Emergency Repair - 200 feet of site repaired in March 2017. Additional 50 feet requires repair after water receded. \$220,000 estimated total for completion and post project permits and mitigation						
Site ID No:488						
Site Designation:LMA-326						
Repair Type: Erosion						
Rating:Area of Concern						
Field Date:7/27/2017						
Notes: Site will likely degrade quickly due to lack of RSP along the lower portion of the bank slope and downstream end of site. At time of field visit, site does not appear to be any imminent threat of failure.

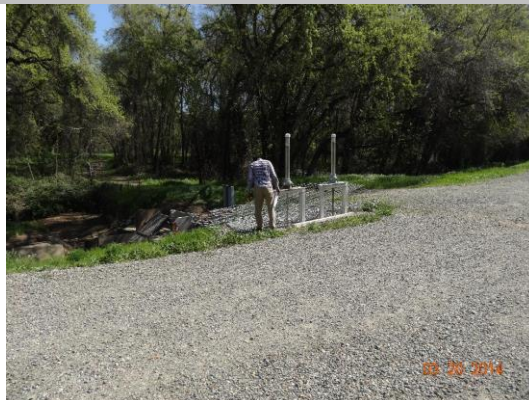
Photo 2 of 3 : UCIP_SP_2018_40045_71907.jpg

Comment Code						
Inspector Comment						
FS_ID:40045 DS_ID:19488 EP_NO: N/A Repair Type: Non-Urgent Crossing Status: Found UCIP Comments: Pipe has been plugged--visible on landward side. Need to contact owner to obtain additional information about abandoned crossing. FIELD_STRUCT_DESC: 1 of 2: 30-inch corrugated metal irrigation pipe through levee, 13.8 feet below crown. Slide gates in 42-diameter riser on waterside (WS) slope. Concrete "U" headwall at both levee toes. Grouted spillway on landside (LS). [Additional Reference(s): DWR Levee Logs, 2005. USACE Sacramento O&M Manual Unit No. 146, November 1962, (HLM 2.67), two 30-inch] FS Date: 3/20/2014

Slide gates visible located on landward side.

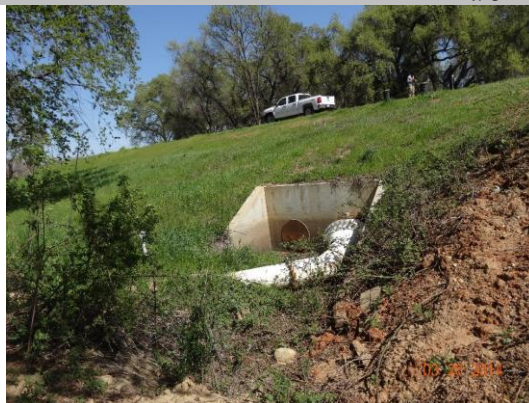
Photo 3 of 3 : UCIP_SP_2018_40045_71912.jpg

Comment Code						
Inspector Comment						
FS_ID:40045 DS_ID:19488 EP_NO: N/A Repair Type: Non-Urgent Crossing Status: Found UCIP Comments: Pipe has been plugged--visible on landward side. Need to contact owner to obtain additional information about abandoned crossing. FIELD_STRUCT_DESC: 1 of 2: 30-inch corrugated metal irrigation pipe through levee, 13.8 feet below crown. Slide gates in 42-diameter riser on waterside (WS) slope. Concrete "U" headwall at both levee toes. Grouted spillway on landside (LS). [Additional Reference(s): DWR Levee Logs, 2005. USACE Sacramento O&M Manual Unit No. 146, November 1962, (HLM 2.67), two 30-inch] FS Date: 3/20/2014

View of waterward side.

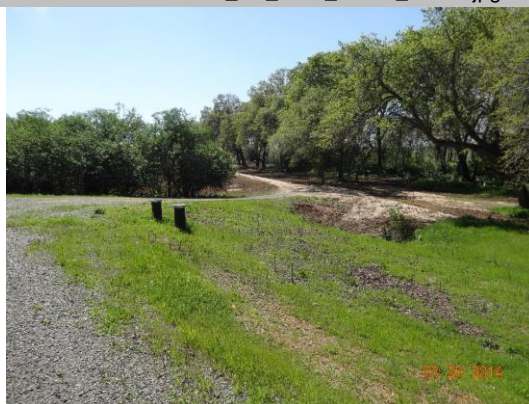
Photo 1 of 3 : UCIP_SP_2018_40046_71915.jpg

Comment Code					
Inspector Comment					
FS_ID:40046 DS_ID:19504 EP_NO: N/A Repair Type: Non-Urgent Crossing Status: Found UCIP Comments: Need to contact owner to determine status--crossing appears to be modified. Need to contact owner to obtain additional information about modified crossing. FIELD_STRUCT_DESC: 2 of 2: 30-inch corrugated metal irrigation pipe through levee, 13.8 feet below crown. Slide gates in 42-diameter riser on waterside (WS) slope. Concrete "U" headwall at both levee toes. Grouted spillway on landside (LS). [Additional Reference(s): DWR Levee Logs, 2005. USACE Sacramento O&M Manual Unit No. 146, November 1962, (HLM 2.67), two 30-inch] FS Date: 3/20/2014

View of waterward side.

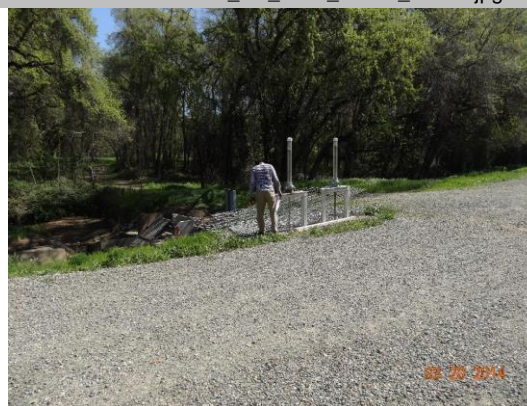
Photo 2 of 3 : UCIP_SP_2018_40046_71914.jpg

Comment Code						
Inspector Comment						
FS_ID:40046 DS_ID:19504 EP_NO: N/A Repair Type: Non-Urgent Crossing Status: Found UCIP Comments: Need to contact owner to determine status--crossing appears to be modified. Need to contact owner to obtain additional information about modified crossing. FIELD_STRUCT_DESC: 2 of 2: 30-inch corrugated metal irrigation pipe through levee, 13.8 feet below crown. Slide gates in 42-diameter riser on waterside (WS) slope. Concrete "U" headwall at both levee toes. Grouted spillway on landside (LS). [Additional Reference(s): DWR Levee Logs, 2005. USACE Sacramento O&M Manual Unit No. 146, November 1962, (HLM 2.67), two 30-inch] FS Date: 3/20/2014

View of landward side.

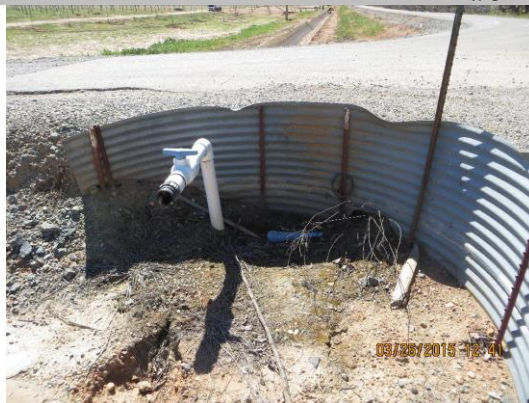
Photo 1 of 2 : UCIP_SP_2018_43957_73435.jpg

LM Start	3.94	Rating **	M	Issue No.	31
LM End	3.94	Issue Type +	En	Location *	
Category	Supplemental			GPS Latitude/Longitude	
				Start	End
Item	DWR UCIP Field Study			39.022486 °	39.022486 °
				-121.379343 °	-121.379343 °
DWR ID					
Comment Code					
Inspector Comment					
FS_ID:43957 DS_ID:19500 EP_NO: N/A Repair Type: Non-Urgent Crossing Status: Indicator Found UCIP Comments: Further evaluation necessary to determine alignment of crossing should be conducted. FIELD_STRUCT_DESC: 4-inch polyvinyl chloride (PVC) water line through levee, 6-feet below the levee crown. Ball valve and service connection point located on the landside (LS) shoulder. Pipe appears to run parallel to east, on LS slope just off crown but may cross at this location as well. [Additional Reference(s): USACE Sacramento O&M Manual Unit No. 146, November 1962, (HLM 4.05)] FS Date: 3/26/2015

Service connection and ball valve visible on LS shoulder.

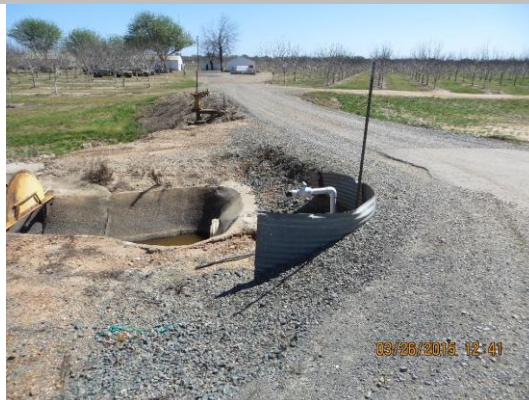
Photo 2 of 2 : UCIP_SP_2018_43957_73434.jpg

Service connection and ball valve visible on LS shoulder.

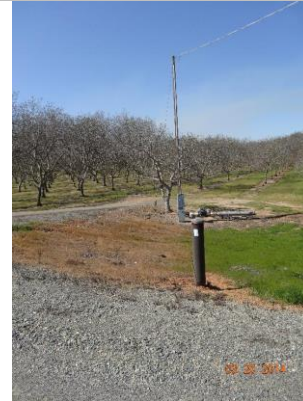
Photo 1 of 3 : UCIP_SP_2018_40048_71922.jpg

Comment Code						
Inspector Comment						
FS_ID:40048 DS_ID:19510 EP_NO: N/A Repair Type: Non-Urgent Crossing Status: Found UCIP Comments: 01/03/2018 Crossing authorized under USACE O&M Manual was removed and replaced with new pipe authorized under Permit No. 18081 (2006). Need to contact owner to obtain as-builts for the current pipe. Current pipe is logged under dsid #####. (DWR UCIP - O. Magana) 03/20/2014 Crossing has been modified---need to contact owner to obtain permit used for modification. (DWR UCIP - O. Magana) FIELD_STRUCT_DESC: *REMOVED* 24-inch corrugated metal irrigation pipe through the levee, 8 feet below the crown. Slide gate in concrete square riser (not corrugated metal pipe riser as mentioned in desk study) located on the waterside (WS) slope. Concrete headwall and trash rack located at toe of WS slope. Breather pipe located on the landside (LS) slope. Pipe discharges in the irrigation ditch located on the landside (LS). Two CM cutoff walls. (no permit found for 24-inch pipe; 24-inch pipe removed and replaced with new 24-inch pipe under Permit No. 18081, 18081-Rev, 2006-Reclamation District No. 2103, four pipes were removed and replaced under this permit) [Additional Reference(s): DWR Levee Logs, 2005. USACE Sacramento O&M Manual Unit No. 146, November 1962, (HLM 4.05)] FS Date: 3/20/2014

View of waterward side.

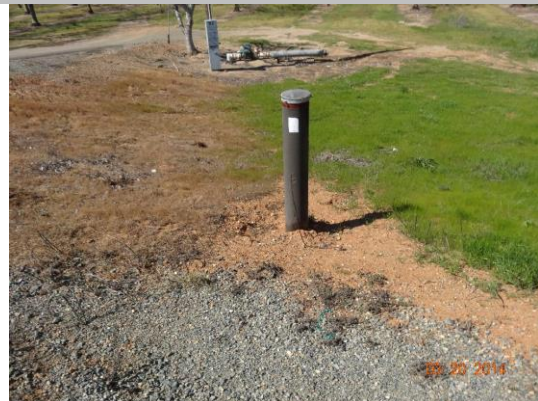
Photo 2 of 3 : UCIP_SP_2018_40048_71921.jpg

Riser located on landward slope.

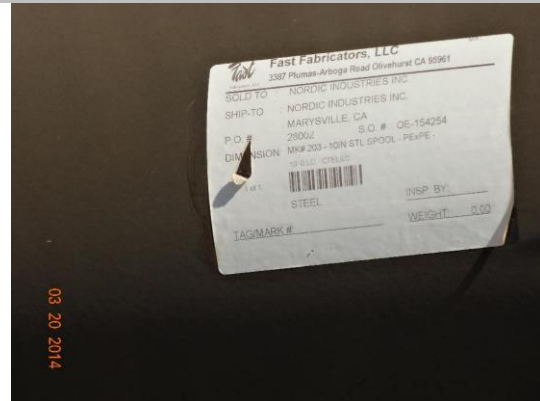
Photo 3 of 3 : UCIP_SP_2018_40048_71920.jpg

Comment Code						
Inspector Comment						
FS_ID:40048 DS_ID:19510 EP_NO: N/A Repair Type: Non-Urgent Crossing Status: Found UCIP Comments: 01/03/2018 Crossing authorized under USACE O&M Manual was removed and replaced with new pipe authorized under Permit No. 18081 (2006). Need to contact owner to obtain as-builts for the current pipe. Current pipe is logged under dsid #####. (DWR UCIP - O. Magana) 03/20/2014 Crossing has been modified---need to contact owner to obtain permit used for modification. (DWR UCIP - O. Magana) FIELD_STRUCT_DESC: *REMOVED* 24-inch corrugated metal irrigation pipe through the levee, 8 feet below the crown. Slide gate in concrete square riser (not corrugated metal pipe riser as mentioned in desk study) located on the waterside (WS) slope. Concrete headwall and trash rack located at toe of WS slope. Breather pipe located on the landside (LS) slope. Pipe discharges in the irrigation ditch located on the landside (LS). Two CM cutoff walls. (no permit found for 24-inch pipe; 24-inch pipe removed and replaced with new 24-inch pipe under Permit No. 18081, 18081-Rev, 2006-Reclamation District No. 2103, four pipes were removed and replaced under this permit) [Additional Reference(s): DWR Levee Logs, 2005. USACE Sacramento O&M Manual Unit No. 146, November 1962, (HLM 4.05)] FS Date: 3/20/2014

Label on riser.

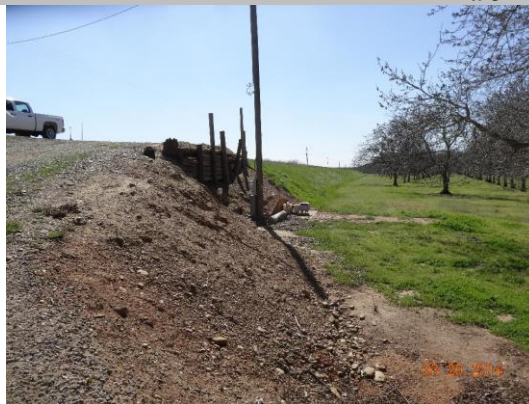
Photo 2 of 3 : UCIP_SP_2018_40049_71926.jpg

Comment Code					
Inspector Comment					
FS_ID:40049					
DS_ID:19493					
EP_NO: N/A					
Repair Type: Non-Urgent					
Crossing Status: Found					
UCIP Comments: Crossing has been modified---need to contact owner to obtain permit used for modification.					
FIELD_STRUCT_DESC: 24-inch corrugated metal irrigation pipe through levee, 10.6 feet below the crown. Slide gate in concrete square riser (not 36-inch CM riser as mentioned in desk study) is located on the waterside (WS) slope. Concrete "U" headwall and trash rack on WS toe. 5-foot by 5-foot concrete distribution box and headwall located on the landside (LS) toe. [Additional Reference(s): DWR Levee Logs, 2005. USACE Sacramento O&M Manual Unit No. 146, November 1962, (HLM 4.87)]					
FS Date: 3/20/2014

Overview of waterward side.
